ICOLD  
27<sup>TH</sup> CONGRESS  
90<sup>TH</sup> ANNUAL  
MEETING

Q106 – Surveillance, Instrumentation, Monitoring and Data Acquisition and Processing/Surveillance, instrumentation, auscultation, acquisition et traitement des données

# PERFORMANCE OF LARGE DAMS UNDER THE 2016-2017 SEISMIC SEQUENCE IN CENTRAL ITALY

Matteo Sbarigia (1), Davide Pauselli (2), Mattia Palmieri (3), Paolo Checcarelli (2), Rosella Caruana (1)

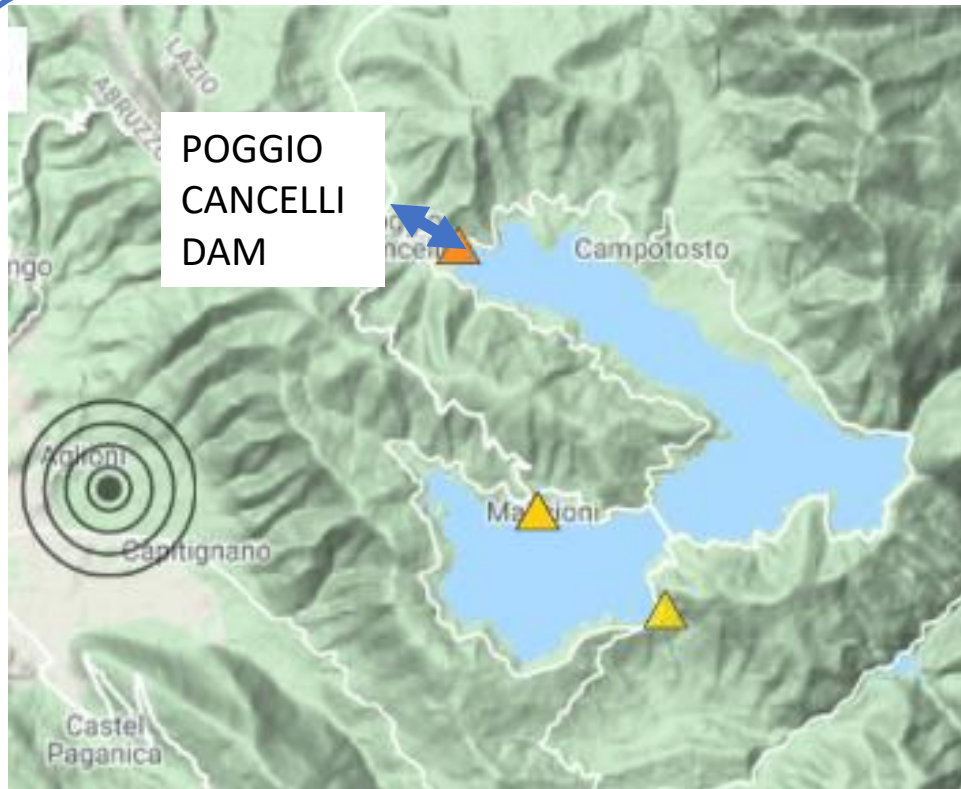
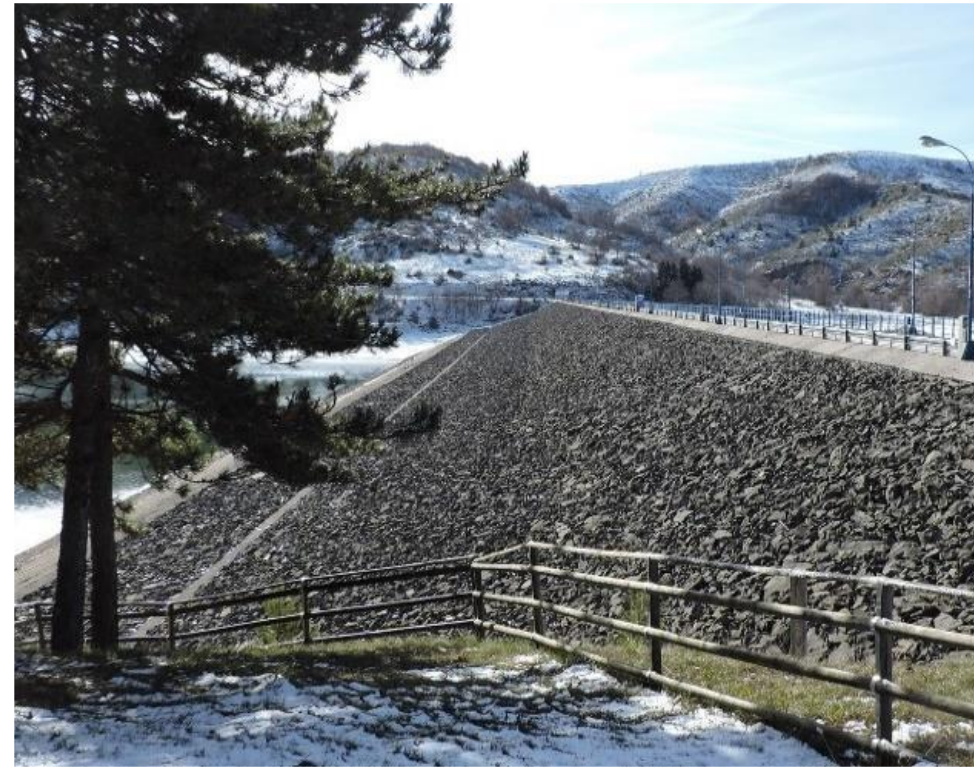
18th January 5.5 Mw “Rieti” earthquake. Poggio Cancelli embankment dam, only 6 km far from the epicenter.

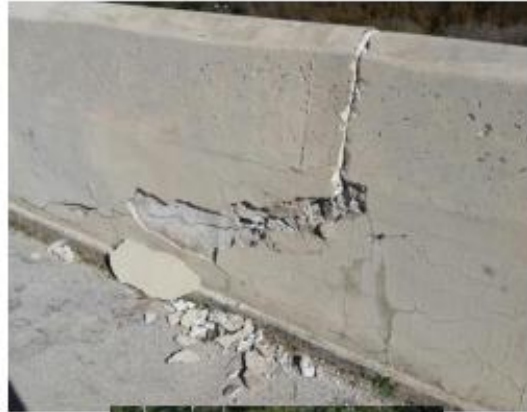
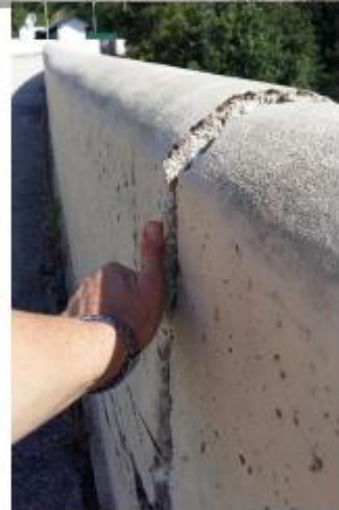
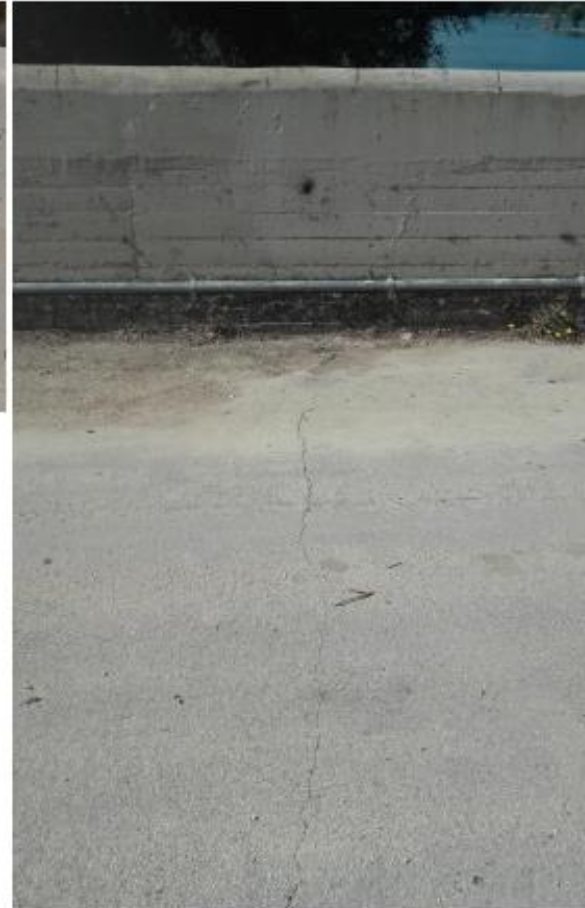
Scandarello Dam. Slight damages on the parapet and crack pattern on the crest.

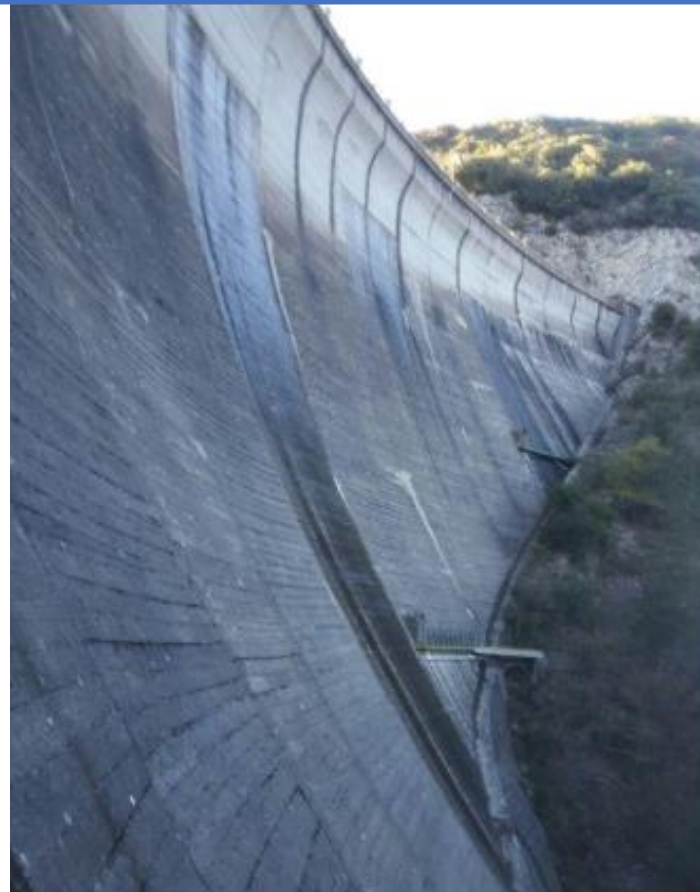
Fiastrone Dam. Increased seepages on the downstream face after 30th Oct 6.5 Mw earthquake.

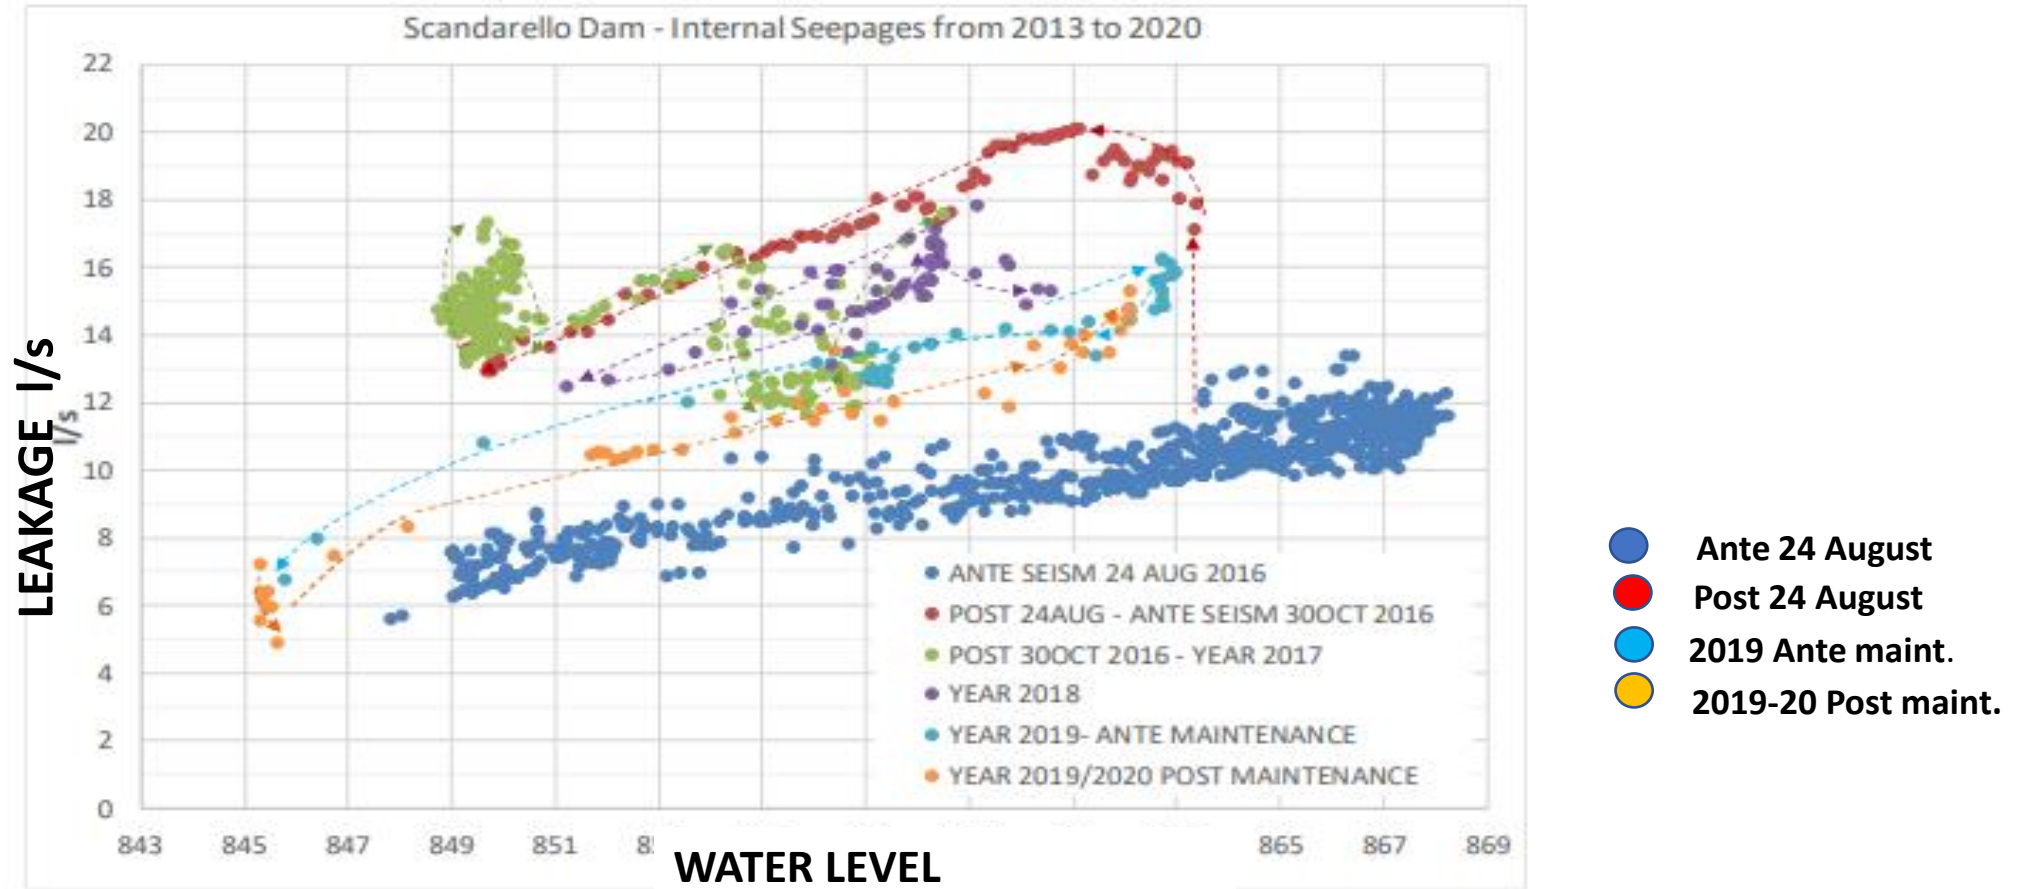
**Scandarello Dam.** Correlation diagram between reservoir water level and internal seepages before and after the major earthquakes, until nowadays.

***Significant increase in the seepages, partially recovered.***

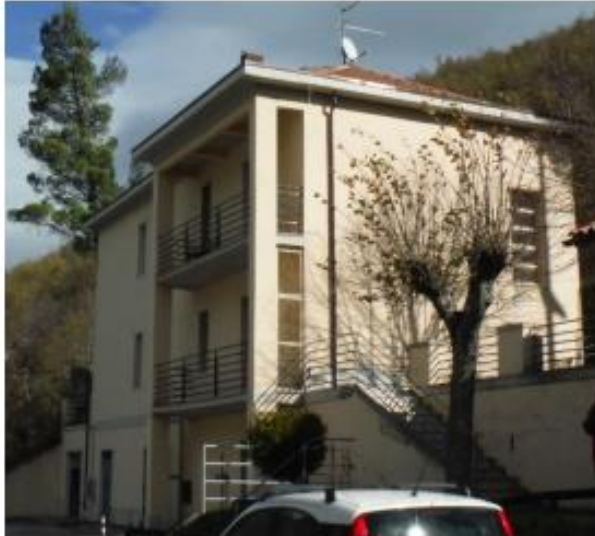
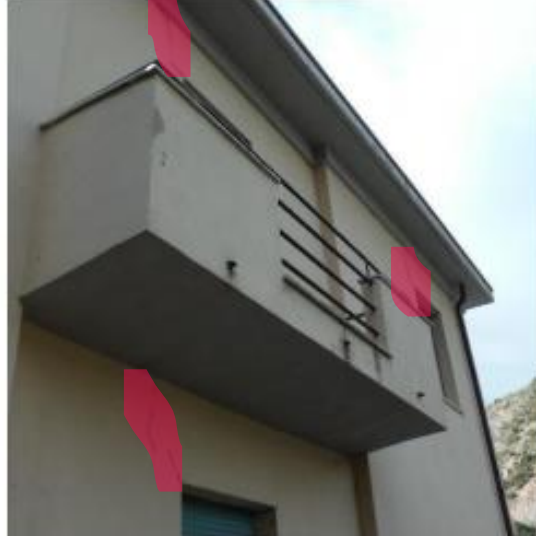
Fiastrone Dam warden’s house with the evidence of the damages due to 24th August 6.0 Mw earthquake (important crack patterns on all the walls).

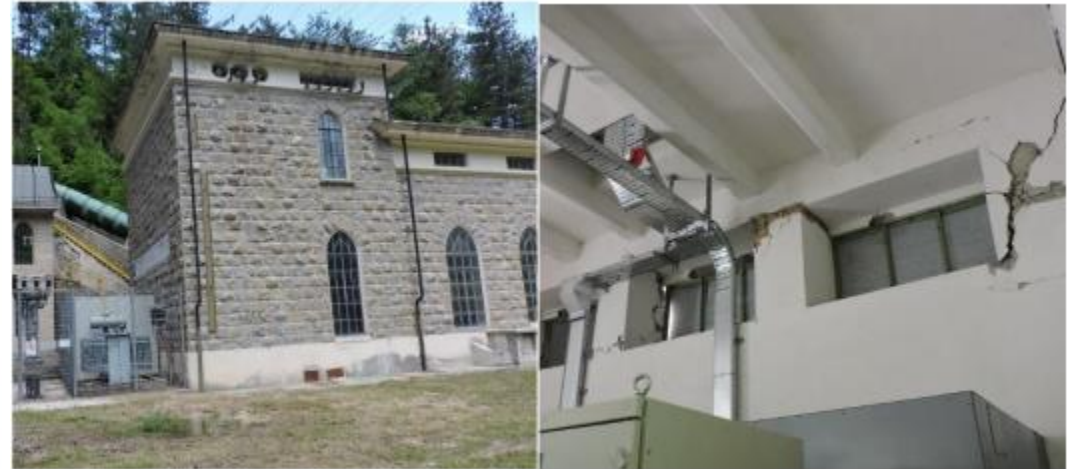
Scandarella hydroelectric power plant – Damages (short columns failed in shear and out of plane mechanisms).
