ICOLD  
27<sup>TH</sup> CONGRESS  
90<sup>TH</sup> ANNUAL  
MEETING

Q106 – Surveillance, Instrumentation, Monitoring and Data Acquisition and Processing/Surveillance, instrumentation, auscultation, acquisition et traitement des données

# PERFORMANCE OF LARGE DAMS UNDER THE 2016-2017 SEISMIC SEQUENCE IN CENTRAL ITALY

Matteo Sbarigia (1), Davide Pauselli (2), Mattia Palmieri (3), Paolo Checcarelli (2), Rosella Caruana (1)

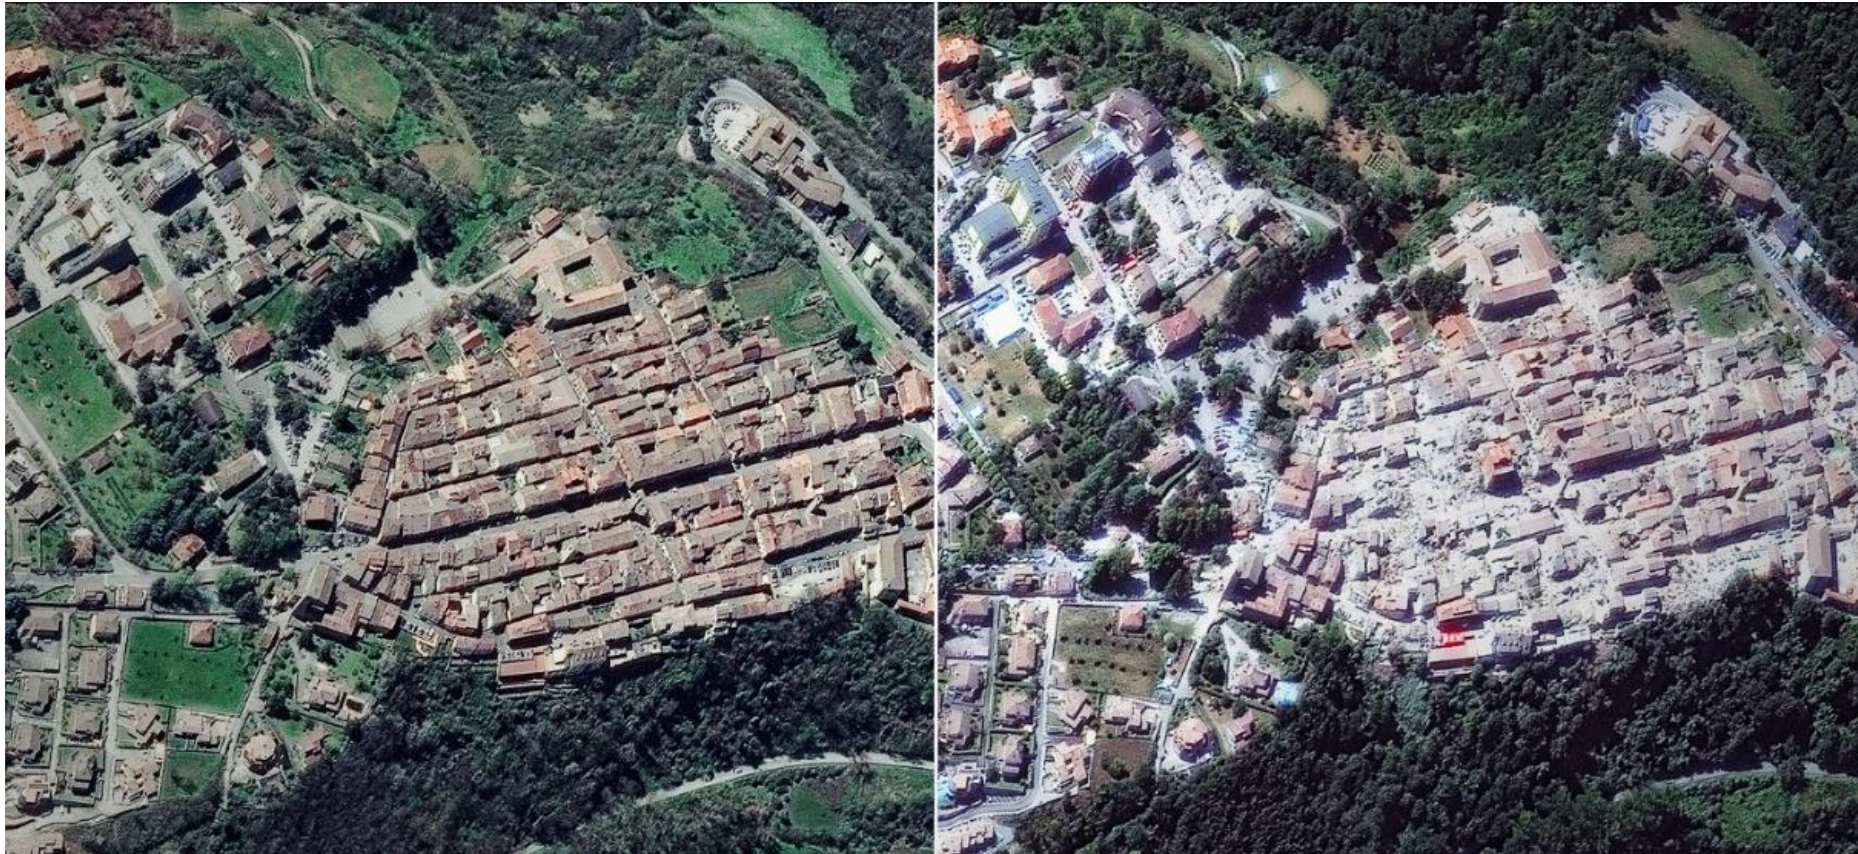
Amatrice town before and after the 24th August Mw 6.0 earthquake.

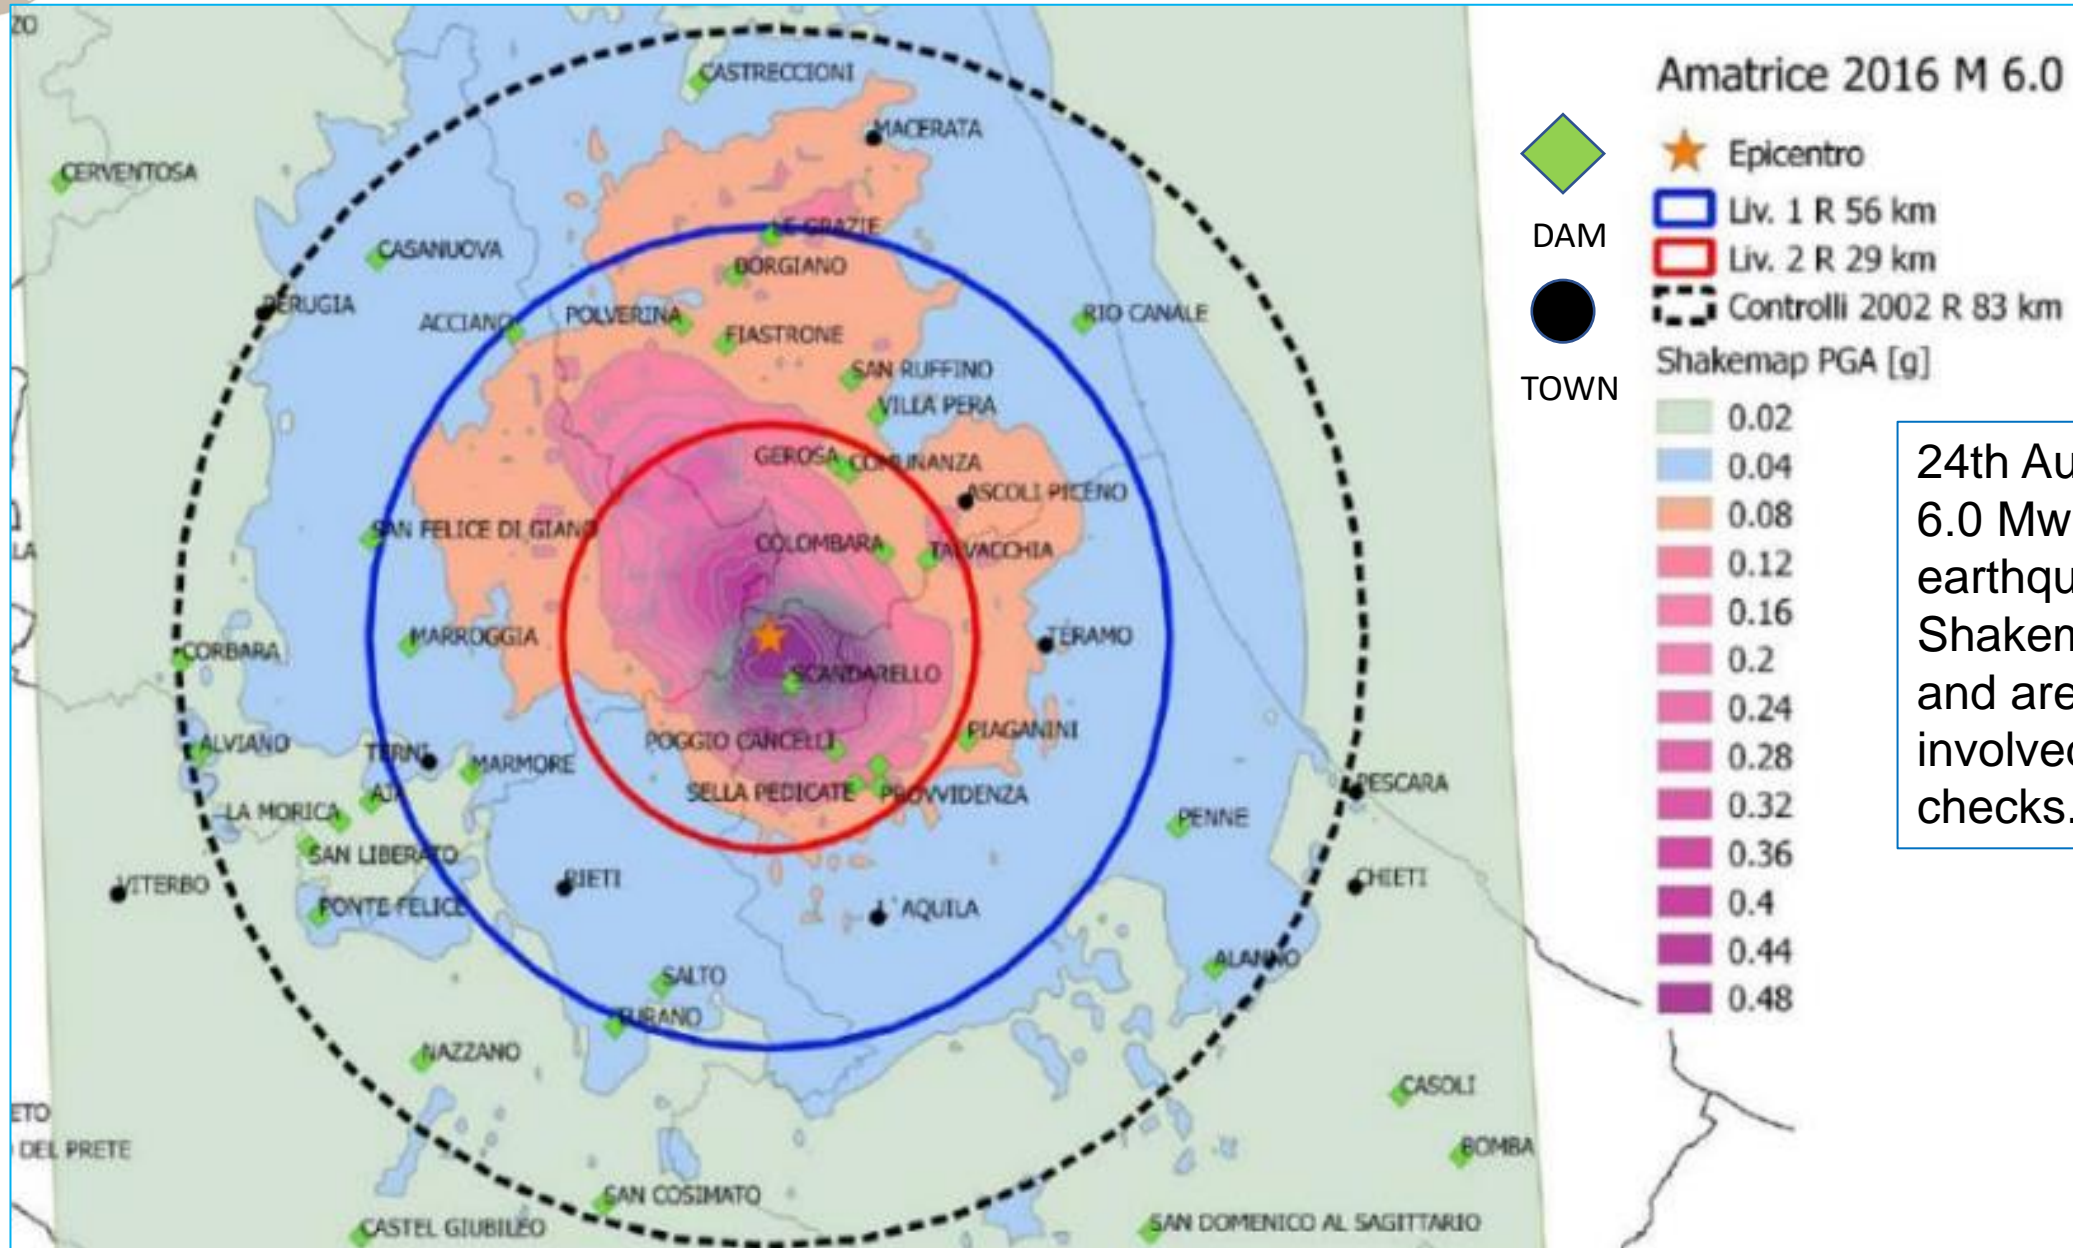
24th August 2016  
6.0 Mw "Amatrice"  
earthquake.  
Shakemap (PGA)  
and areas with dams  
involved in safety  
checks.
